SUMMARY REPORT

Client: Warranty Sample
Inspection Address: Hummingbird Lane, Anthem, AZ 85086
Inspection Date: 12/3/2004 Start: 9:30 am
Inspected by: Sean Preston

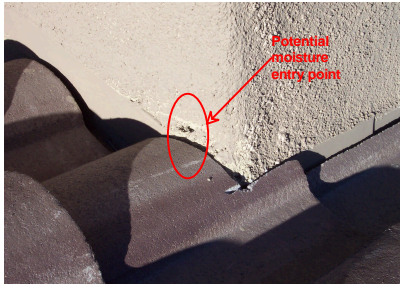
- There are stress fractures in the stucco around the windows and doors that result from movement, and are quite common. Recommend repair by builder prior to the expiration of the warranty.
- There is a hole in the stucco at the front of the house on the right side of the garage, where the roof meets the wall. Recommend patching the hole to protect from potential water penetration.

Various holes in stucco at back patio.

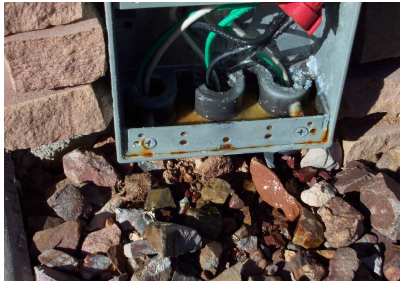
- The Electrical Box at the front yard wall has moisture penetrating it. Moisture is likely entering from the light on the column. Recommend proper sealing of the light fixture to the post.

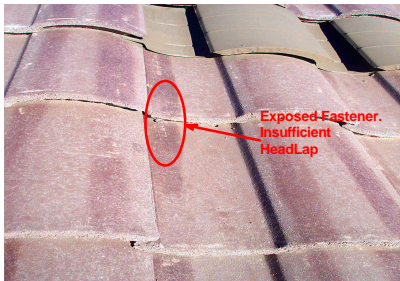
- On the south side of the ridge near the vents 2/3 of the way towards the front of the house, there is insufficient head lap on the tile and the mechanical fastener is exposed.

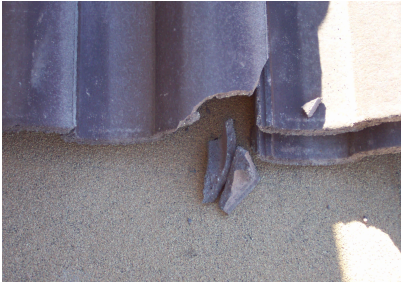
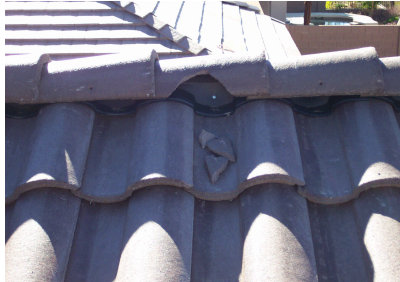
- There are multiple broken tiles at the north face of the rear gable. Recommend repair of the broken tiles by licensed roofing contractor.

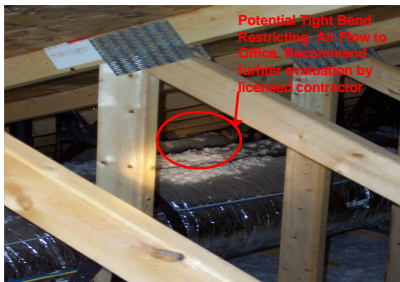
- The airflow from the register in the office is less than the other areas. In the attic it appears that the duct may have a tight bend to it restricting airflow.
