## SUMMARY REPORT

**Client:** New Construction Buyer  
**Inspection Address:** Camelot Homes, Glendale , Arizona  
**Inspection Date:** 1/3/2005  
**Inspected by:** Sean Preston

## **CONFIDENTIAL INSPECTION REPORT**

Camelot Homes, Glendale , Arizona

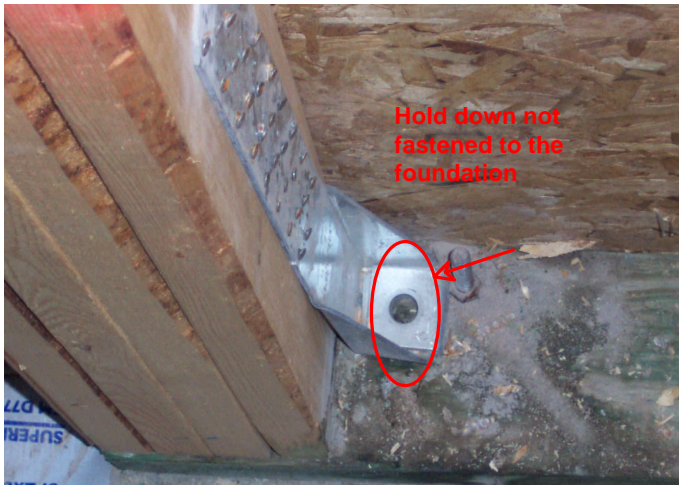
- 1.1 - At the south wall a number of the hold downs are not fastened to the foundation. Recommend proper fastening per engineering specifications.  
*See Attached Picture(s) - Figure Set 1*

Figure Set - 1 There are numerous hold downs not fastened at the south wall

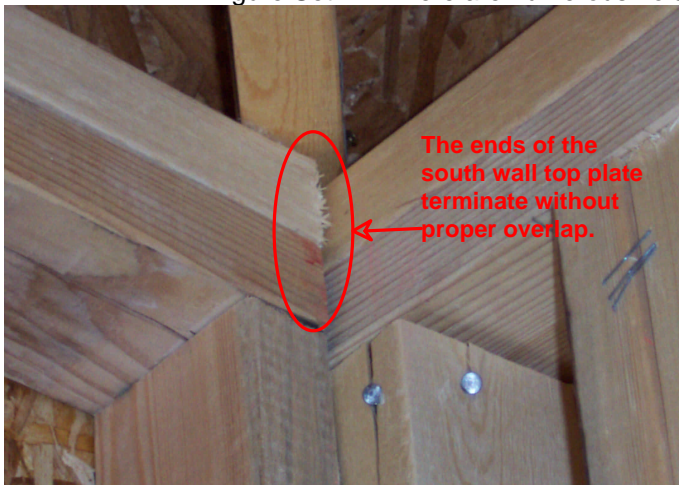
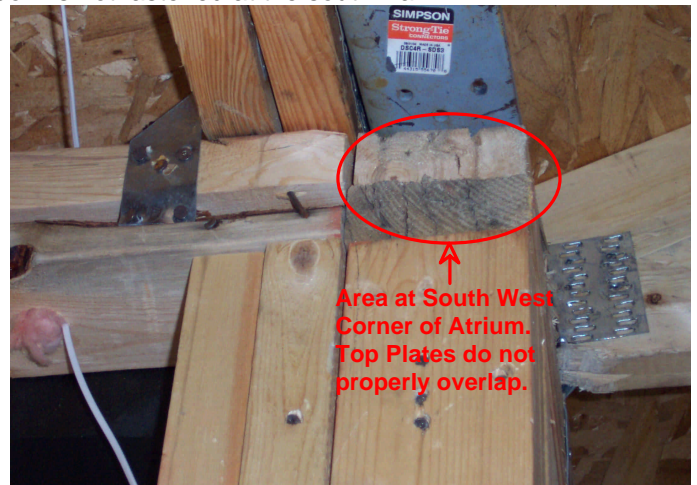
- 1.2 - At wall intersections and corners the Top Plates of the bearing walls must overlap. The top plates were inspected and there was not proper overlap at the Up Stairs Back Right Bedroom Southwest corner and the Southwest corner of the Atrium (near stairwell). Recommend repair as prescribed by engineer.

R602.3.2 Top plate. Wood stud walls shall be capped with a double top plate installed to provide overlapping at corners and intersections with bearing partitions. End joints in top plates shall be offset at least 24 inches (610 mm). Plates shall be a nominal 2 inches in depth (51 mm) and have a width at least equal to the width of the studs.  
*See Attached Picture(s) - Figure Set 2*

Figure Set - 2 The top plate must overlap at wall intersections and corners

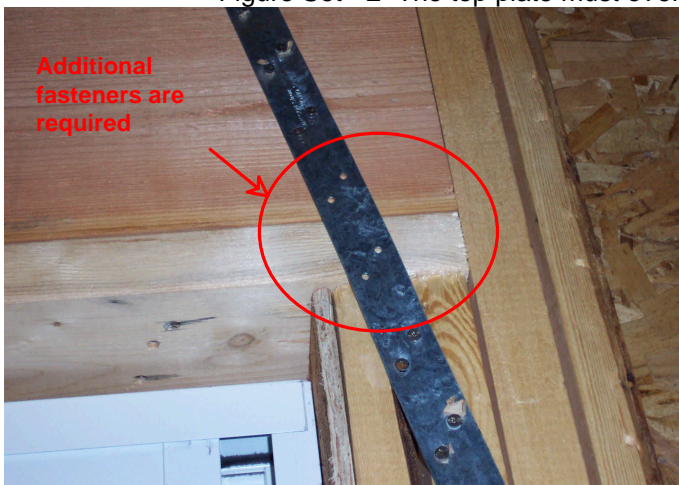
- 1.3 - The strapping at the header in the lower level bedroom is not properly fastened. Recommend installation of additional approved fasteners.  
*See Attached Picture(s) - Figure Set 3*

Figure Set - 3 The strapping at the header in the lower level bedroom is not properly fastened

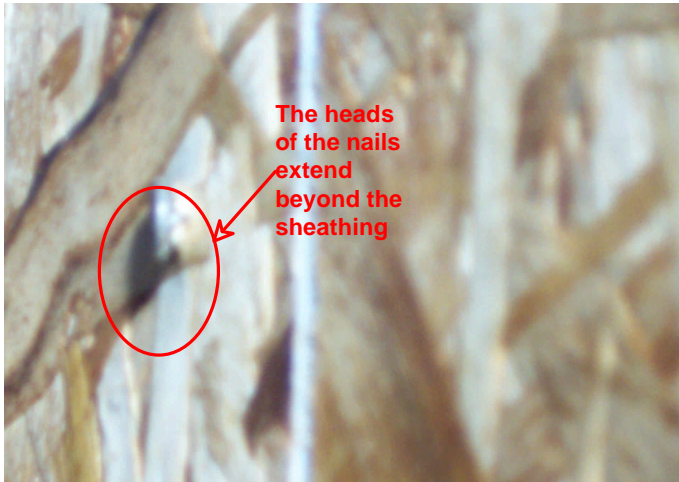
- 1.4 - The fastening of the sheathing at the stairwall wall is not proper, Greater than 20% of the nails are not properly driven. Proper fastening technique is important as this shear wall contributes to the structural integrity of the home.

2000 IBC 2304.9.2 Sheathing nails or other approved sheathing connectors shall be driven so that their head or crown is flush with the surface of the sheathing.

The heads  
of the nails  
extend  
beyond the  
sheathing

Figure Set - 4 The fastening of the sheathing at the stairwell wall is not proper

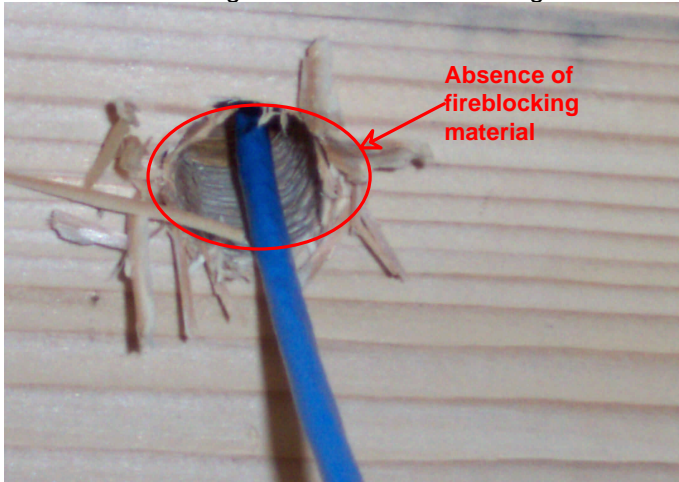
- 1.5 - There are numerous locations where the required firestopping materials is not present. There are too many locations to practically list, In general, the penetrations that do not meet the firestopping requirements include the gas line penetrations, the data/video cabling penetrations. Recommend installation of firestopping materials at locations mentioned as well as any other locations that are not noted but required.

602.8 Fireblocking required. Fireblocking shall be provided to cut off all concealed draft openings (both vertical and horizontal) and to form an effective fire barrier between stories, and between a top story and the roof space. Fireblocking shall be provided in wood-frame construction in the following locations.

Absence of  
fireblocking  
material

Figure Set - 5 Firestopping is required at penetrations

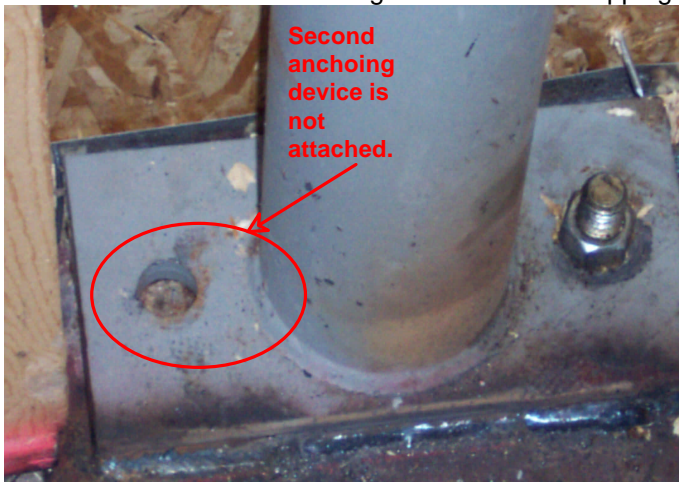
- 1.6 - The column supporting the bearing beam is not properly fastened to the foundation. At the west side of the beam, the column is fastened with only one bolt. Recommend repair per engineering specifications.  
*See Attached Picture(s) - Figure Set 6*

Second  
anchoring  
device is  
not  
attached.

Figure Set - 6 The column supporting the bearing beam is not properly fastened to the foundation

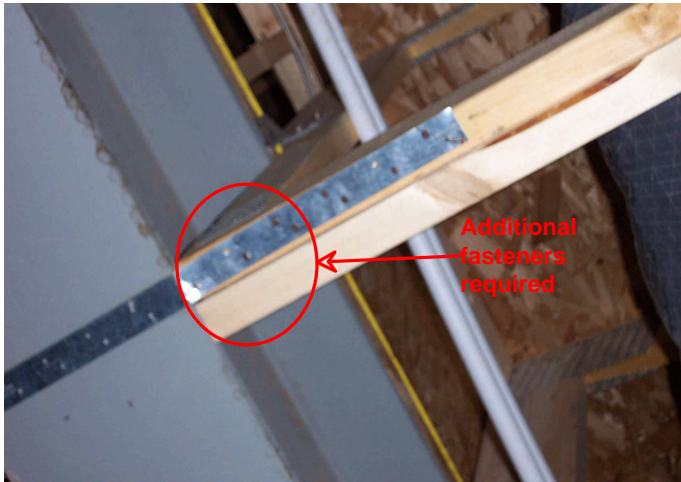
- 1.7 - At the bearing beam, the strapping connecting the trusses on either side requires additional fasteners. Each available hole within the straps require fasteners. Recommend addition of specified fasteners.  
*See Attached Picture(s) - Figure Set 7*

Figure Set - 7 Additional fasteners required at strapping adjacent to bearing beam

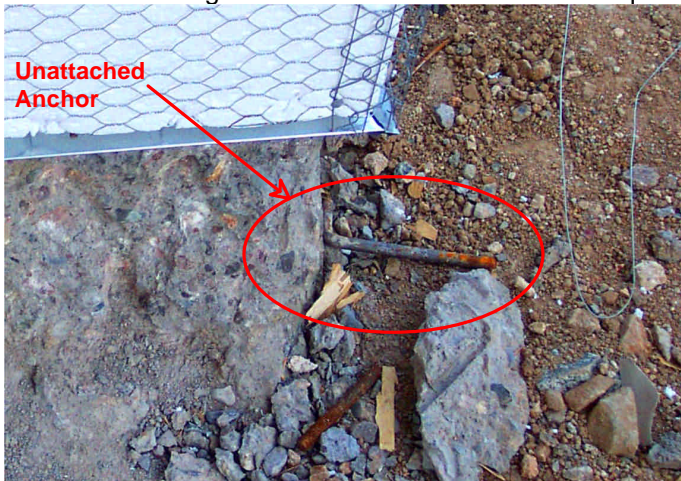
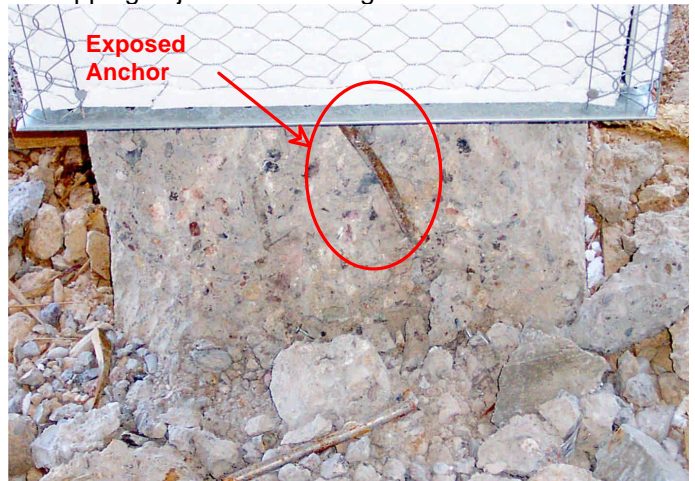
- 2.1 - It appears that the size of the footers is being altered. An anchor is exposed while another anchor was found unattached adjacent to the post. Recommend ensuring adequate attachment is present at modified footers and repair of the concrete to protect any exposed anchors from the elements and provide an aesthetically pleasing finished product.  
*See Attached Picture(s) - Figure Set 8*

Figure Set - 8 The footers for the posts at the rear patio are in the process of being modified

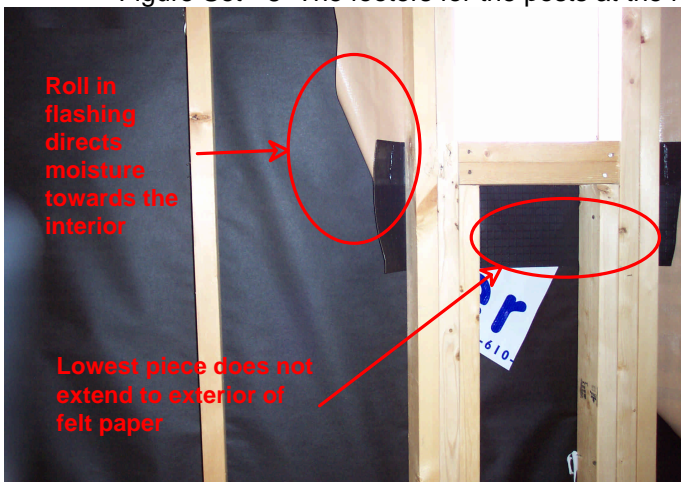
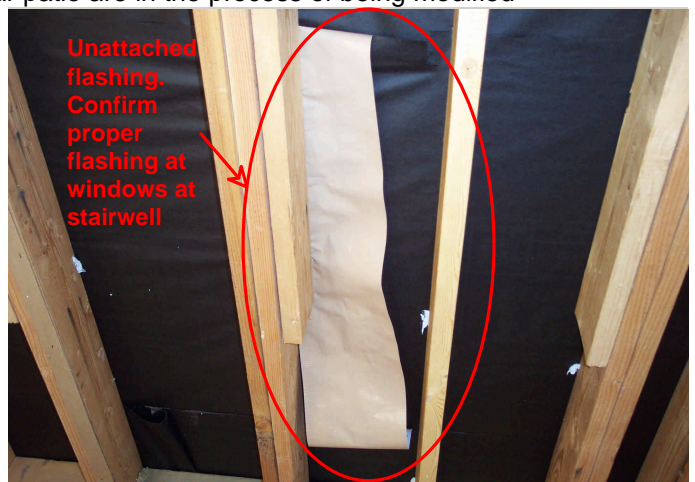
- 2.2 - The window flashings at the following locations is not properly installed:  
Room at North East corner of home  
Master Bedroom closet  
Stairwell - Presence of unattached flashing, confirm proper flashing at all windows

The flashing is to be installed in a manner that all laps shed water, with the lower level overlapped by the upper levels and the lower level terminating on the exterior side of the felt paper.  
*See Attached Picture(s) - Figure Set 9*

Figure Set - 9 The window flashing at various locations is not properly installed

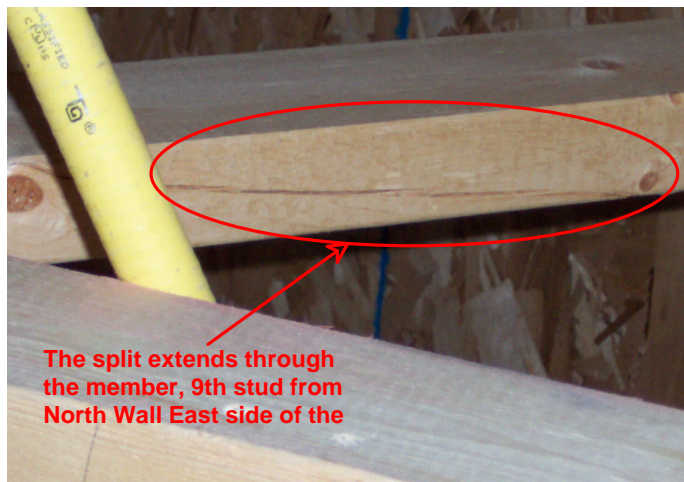
- 3.1 - A broken truss was located at the second story East side at the North side of the house. Counting back from the North wall towards the master bedroom closet it is the 9th truss. The web at the East side of the truss is beginning to split. Recommend repair as prescribed by an engineer.  
*See Attached Picture(s) - Figure Set 10*

Figure Set - 10 A broken truss was located at the second story East side at the North side of the house

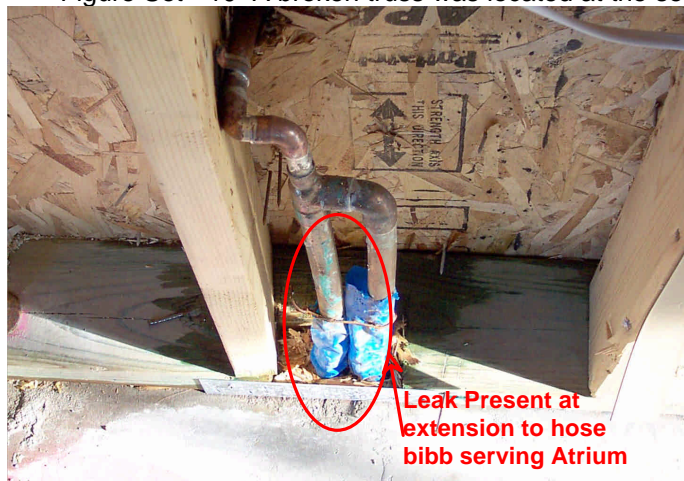
- 4.1 - There is a leak present at the extension to the hose bibb serving the Atrium area. Recommend repair by plumber.  
*See Attached Picture(s) - Figure Set 11*

Figure Set - 11 Leak present at hose bib

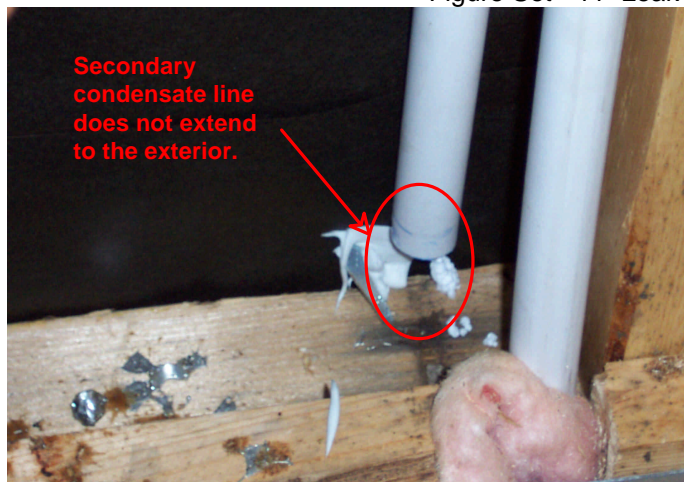
- 5.1 - The secondary condensate line for the HVAC system mounted at the East side of the home does not extend to the exterior. The condensate line terminates within the master bathroom. Recommend extending the condensate line to the exterior.

M1411.3 Condensate disposal. Condensate from all cooling coils or evaporators shall be conveyed from the drain pan outlet to an approved place of disposal. Condensate shall not discharge into a street, alley or other areas so as to cause a nuisance.  
*See Attached Picture(s) - Figure Set 12*

Figure Set - 12 The secondary condensate line does not extend to the exterior

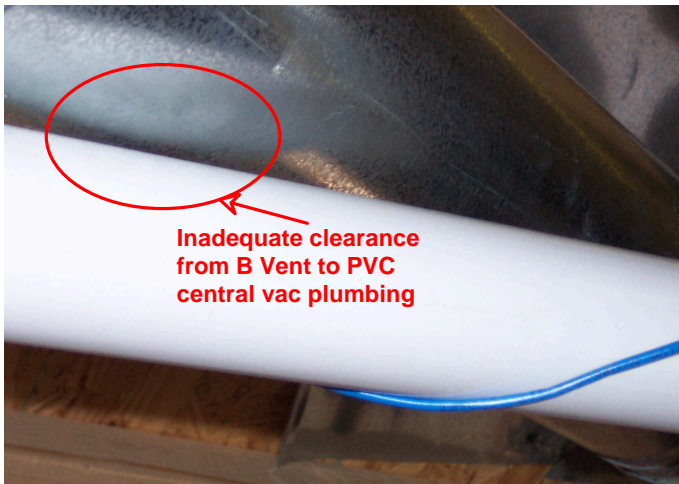
5.2 - The flue for the hot water heater appears to be positioned too close to the PVC piping for the central vacuum system. The clearance to combustibles for type B venting is 1". Recommend increasing the clearance.

Figure Set - 13 Improper clearance to combustible materials at hot water heater flue

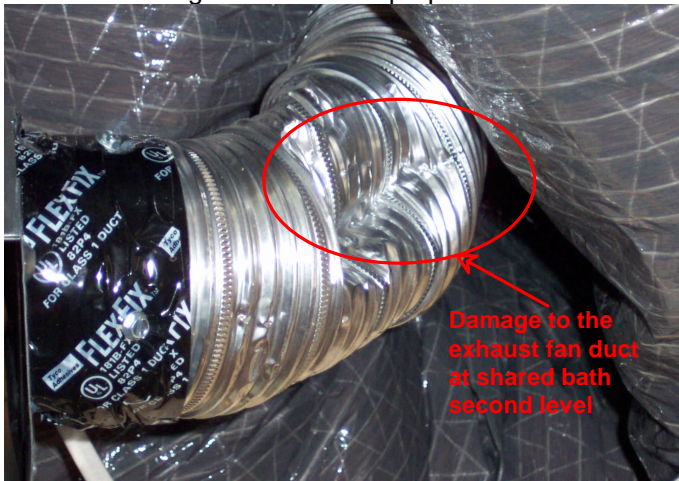
5.3 - At the shared bath on the second level, the exhaust fan duct work is damaged and constricted. Recommend replacement of this section of the duct.

Figure Set - 14 The ductwork for the exhaust fan is constricted

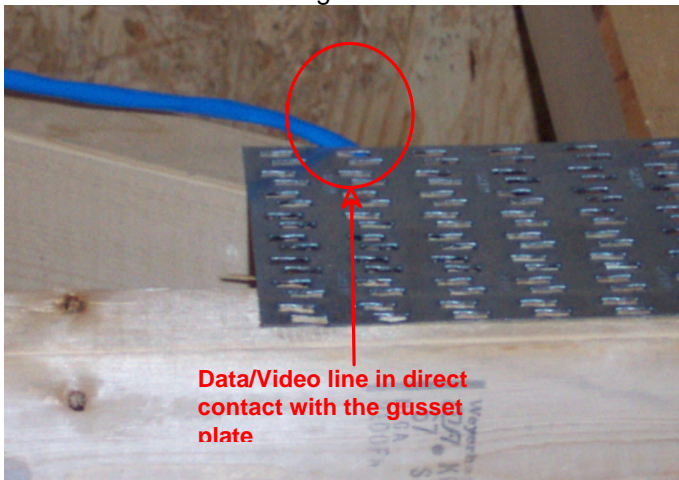
6.1 - At the lower level bedroom, a data/video cable is run against the gusset plate. Recommend moving the cable to protect from damage.

Figure Set - 15 The structured wiring is in contact with the gusset plate

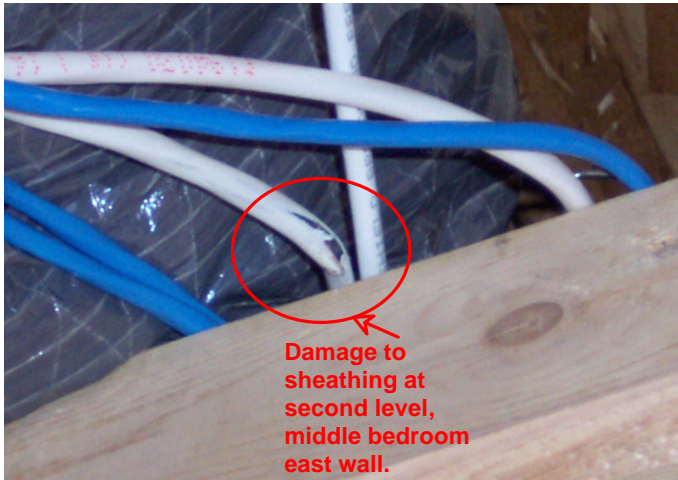
8.1 - At the middle back bedroom adjacent to the East wall second level, a section of the wirings protective sheath is damaged. Recommend replacement of this section of cable.

Figure Set - 16 The sheathing is torn on a section of the electrical cable

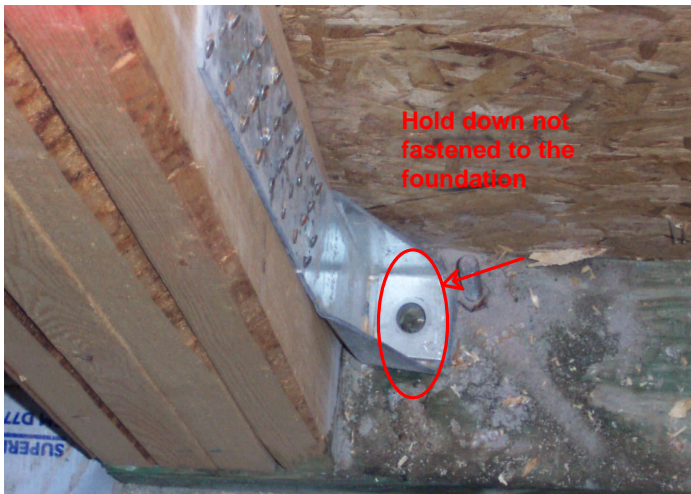
1.3 - At the south wall a number of the hold downs are not fastened to the foundation. Recommend proper fastening per engineering specifications.

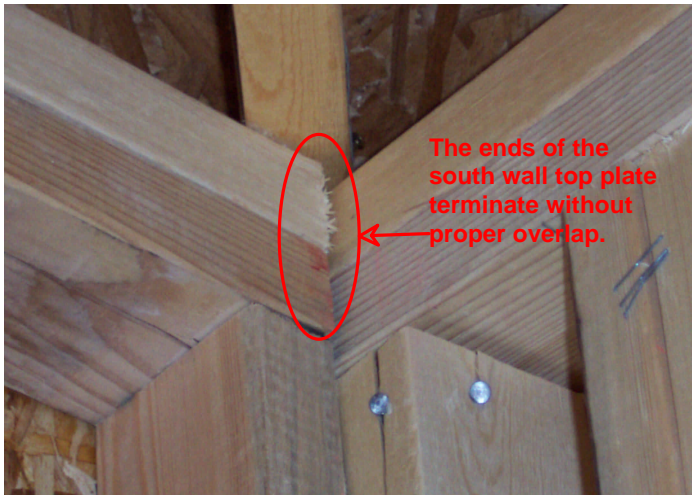
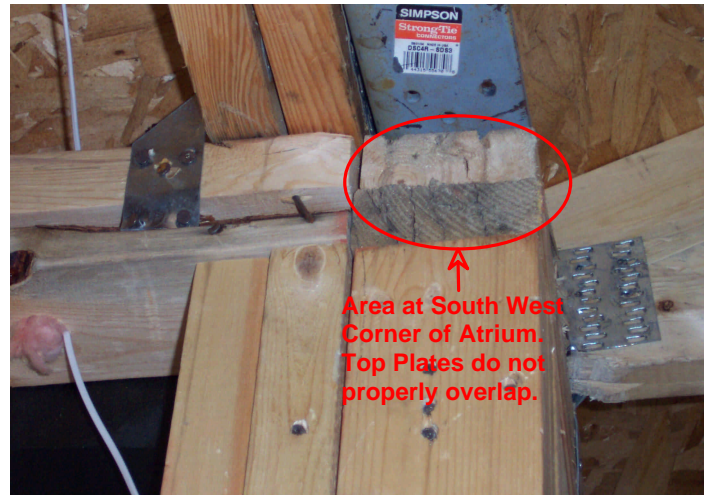
and the Southwest corner of the Atrium (near stairwell). Recommend repair as prescribed by engineer.

R602.3.2 Top plate. Wood stud walls shall be capped with a double top plate installed to provide overlapping at corners and intersections with bearing partitions. End joints in top plates shall be offset at least 24 inches (610 mm). Plates shall be a nominal 2 inches in depth (51 mm) and have a width at least equal to the width of the studs.

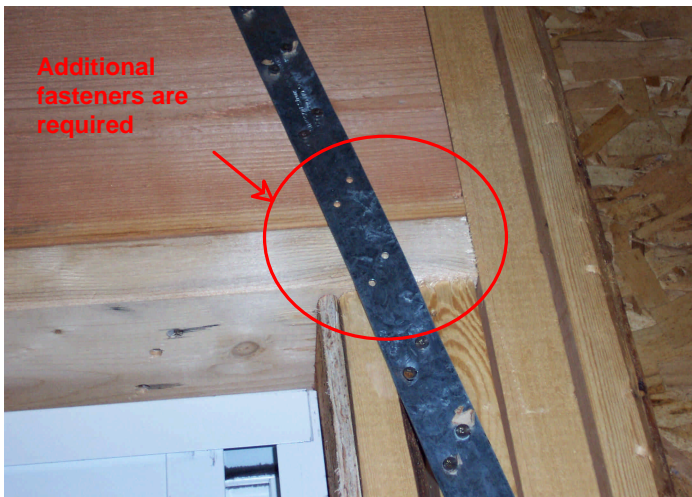
1.9 - The strapping at the header in the lower level bedroom is not properly fastened. Recommend installation of additional approved fasteners.

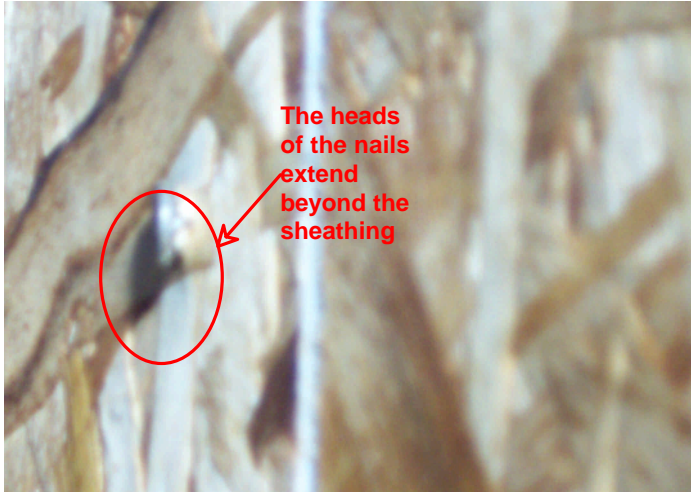
1.10 - The fastening of the sheathing at the stairwall wall is not proper, Greater than 20% of the nails are not properly driven. Proper fastening technique is important as this shear wall contributes to the structural integrity of the home.

2000 IBC 2304.9.2 Sheathing nails or other approved sheathing connectors shall be driven so that their head or crown is flush with the surface of the sheathing.

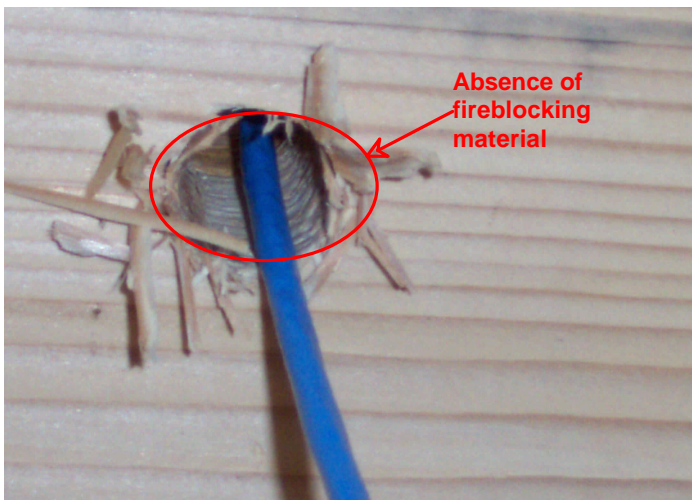
1.13 - There are numerous locations where the required firestopping materials is not present. There are too many locations to practically list, In general, the penetrations that do not meet the firestopping requirements include the gas line penetrations, the data/video cabling penetrations. Recommend installation of firestopping materials at locations mentioned as well as any other locations that are not noted but required.

vertical and horizontal) and to form an effective fire barrier between stories, and between a top story and the roof space. Fireblocking shall be provided in wood-frame construction in the following locations.

1. In concealed spaces of stud walls and partitions, including furred spaces and parallel rows of studs or staggered studs; as follows:
  - 1.1. Vertically at the ceiling and floor levels.
  - 1.2. Horizontally at intervals not exceeding 10 feet (3048 mm).
2. At all interconnections between concealed vertical and horizontal spaces such as occur at soffits, drop ceilings and cove ceilings.
3. In concealed spaces between stair stringers at the top and bottom of the run. Enclosed spaces under stairs shall comply with Section R311.2.2.
4. At openings around vents, pipes, and ducts at ceiling and floor level, with an approved material to resist the free passage of flame and products of combustion.
5. For the fireblocking of chimneys and fireplaces, see Section R1001.16.
6. Fireblocking of cornices of a two-family dwelling is required at the line of dwelling unit separation.

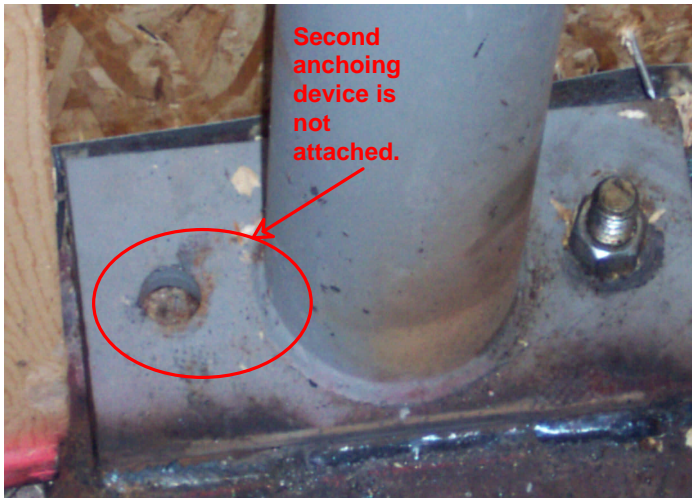
- 1.16 - The column supporting the bearing beam is not properly fastened to the foundation. At the west side of the beam, the column is fastened with only one bolt. Recommend repair per engineering specifications.

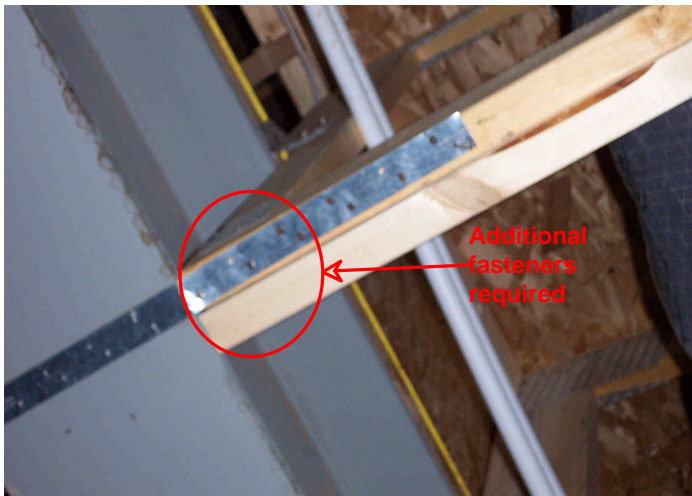
1.17 - At the bearing beam, the strapping connecting the trusses on either side requires additional fasteners. Each available hole within the straps require fasteners. Recommend addition of specified fasteners.

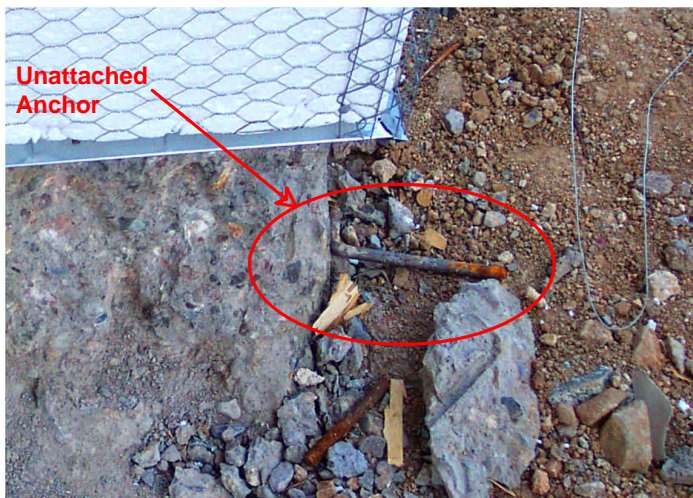
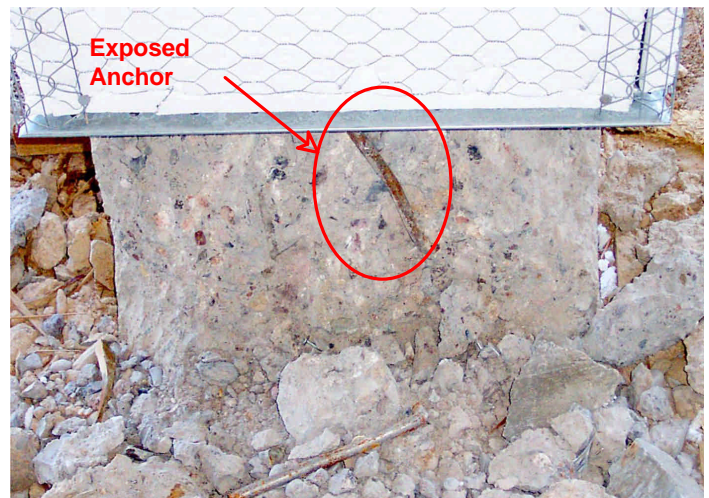
2.2 - It appears that the size of the footers is being altered. An anchor is exposed while another anchor was found unattached adjacent to the post. Recommend ensuring adequate attachment is present at modified footers and repair of the concrete to protect any exposed anchors from the elements and provide an aesthetically pleasing finished product.

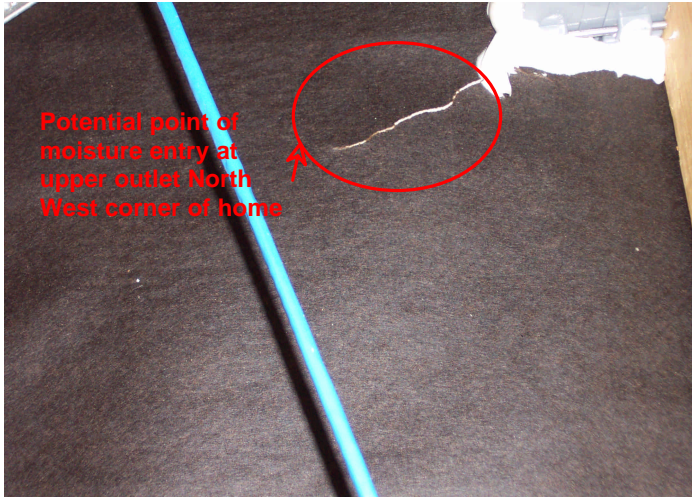
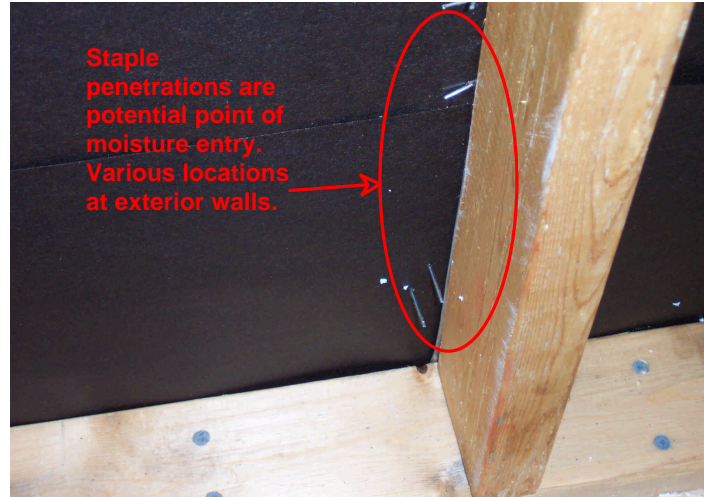
2.5 - The building is wrapped in a felt paper moisture barrier. There are a number of potential points of entry for moisture. Recommend proper sealing of the following areas:

Upstairs Front Right Bedroom, multiple staple penetrations and at the outlet box on the upper West wall  
The upstairs East Wall has numerous unsealed staple penetrations

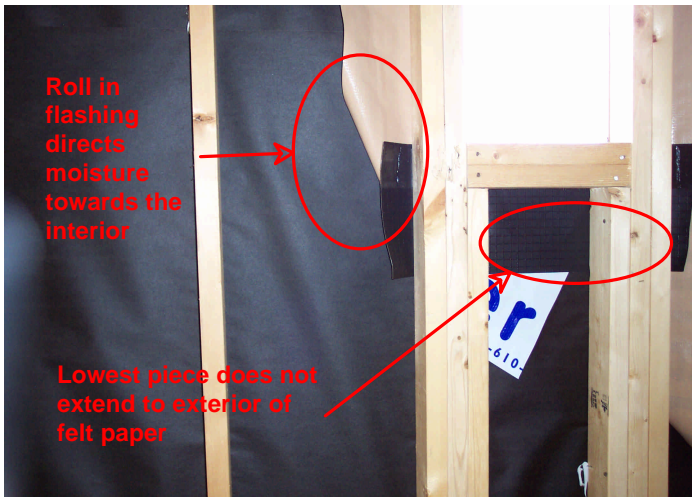
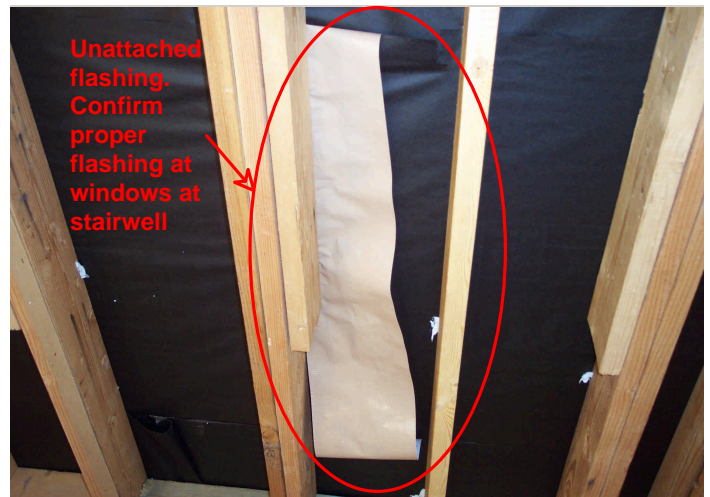
- 2.6 - The window flashings at the following locations is not properly installed:
  - Room at North East corner of home
  - Master Bedroom closet
  - Stairwell - Presence of unattached flashing, confirm proper flashing at all windows

The flashing is to be installed in a manner that all laps shed water, with the lower level overlapped by the upper levels and the lower level terminating on the exterior side of the felt paper.

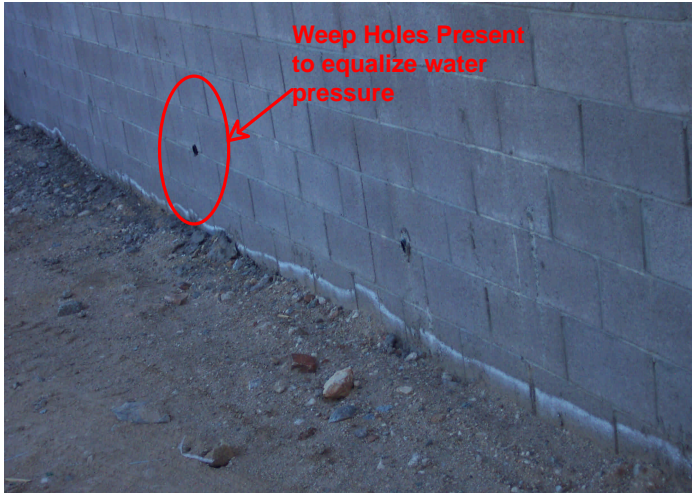
2.7 - The retaining wall at the west side of the property is in acceptable condition

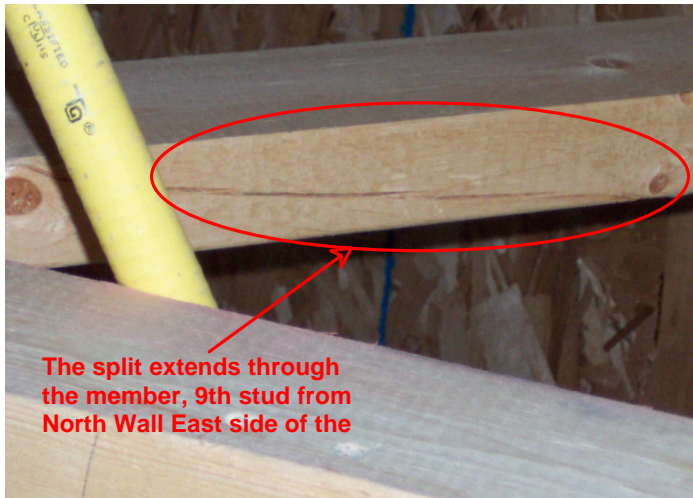
3.1 - A broken truss was located at the second story East side at the North side of the house. Counting back from the North wall towards the master bedroom closet it is the 9th truss. The web at the East side of the truss is beginning to split. Recommend repair as prescribed by an engineer.

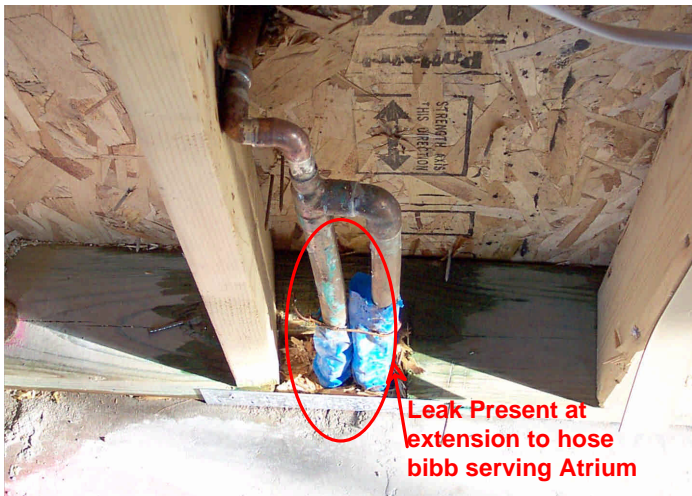
- 4.5 - There is a leak present at the extension to the hose bibb serving the Atrium area. Recommend repair by plumber.

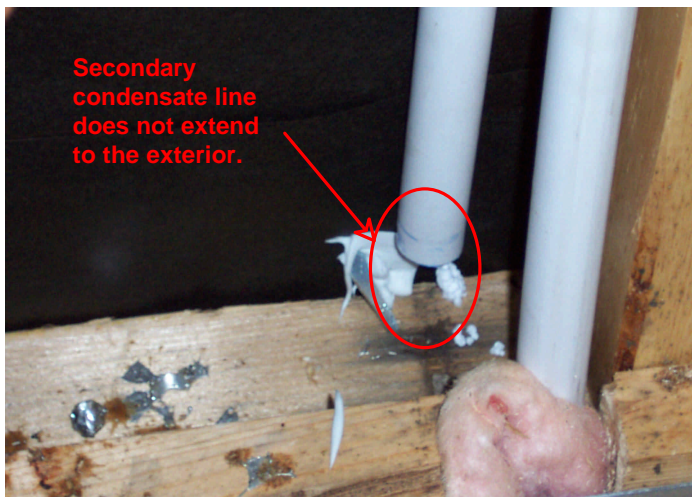
5.4 - The secondary condensate line for the HVAC system mounted at the East side of the home does not extend to the exterior. The condensate line terminates within the master bathroom. Recommend extending the condensate line to the exterior.

M1411.3 Condensate disposal. Condensate from all cooling coils or evaporators shall be conveyed from the drain pan outlet to an approved place of disposal. Condensate shall not discharge into a street, alley or other areas so as to cause a nuisance.

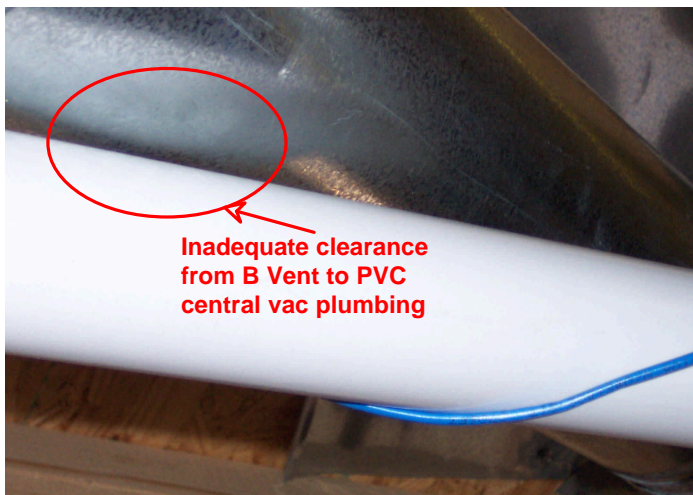
5.9 - The flue for the hot water heater appears to be positioned too close to the PVC piping for the central vacuum system. The clearance to combustibles for type B venting is 1". Recommend increasing the clearance.

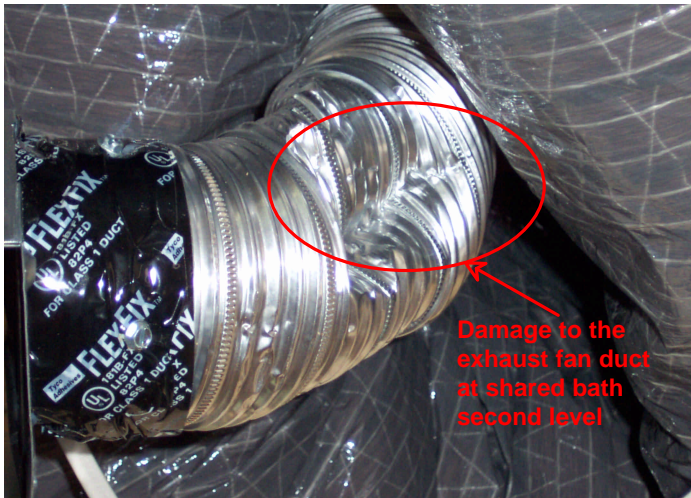
5.11 - At the shared bath on the second level, the exhaust fan duct work is damaged and constricted. Recommend replacement of this section of the duct.

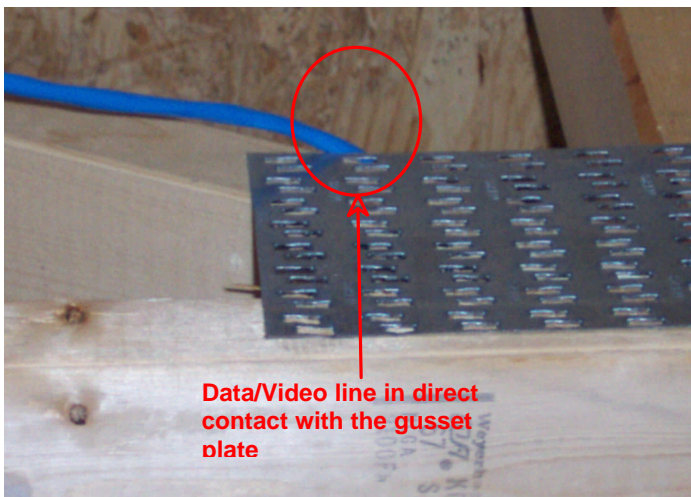
6.1 - At the lower level bedroom, a data/video cable is run against the gusset plate. Recommend moving the cable to protect from damage.

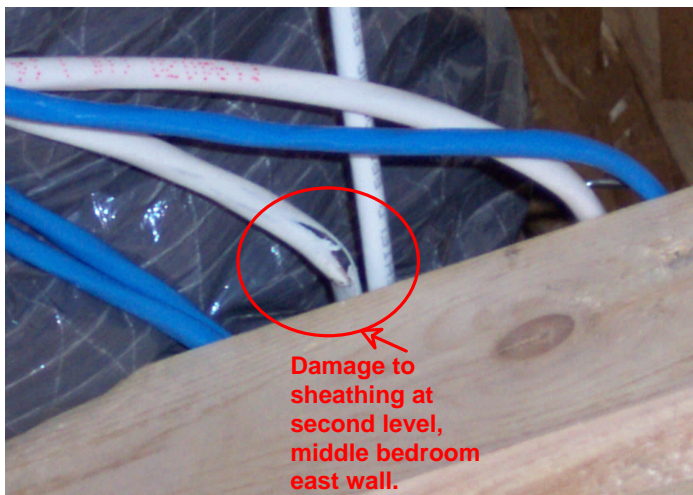
8.11 - At the middle back bedroom adjacent to the East wall second level, a section of the wirings protective sheath is damaged. Recommend replacement of this section of cable.
