CONFIDENTIAL INSPECTION REPORT

Warranty Sample

Hummingbird Lane, Anthem, AZ 85086

12/3/2004 9:30 am

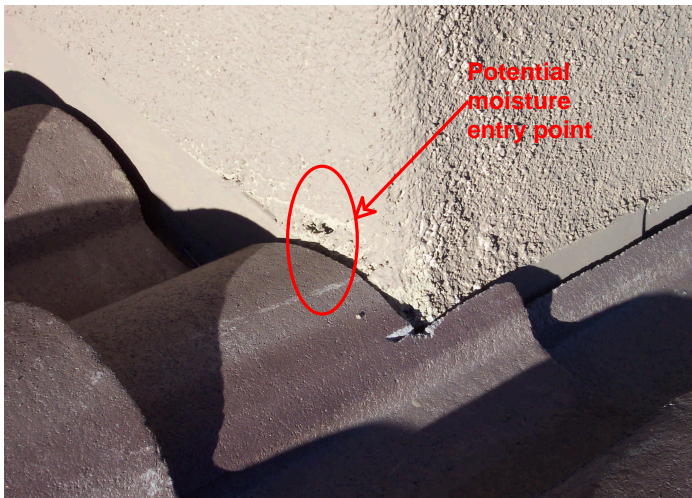
There is a hole in the stucco at the front of the house on the right side of the garage, where the roof meets the wall. Recommend patching the hole to protect from potential water penetration.

Various holes in stucco at back patio.

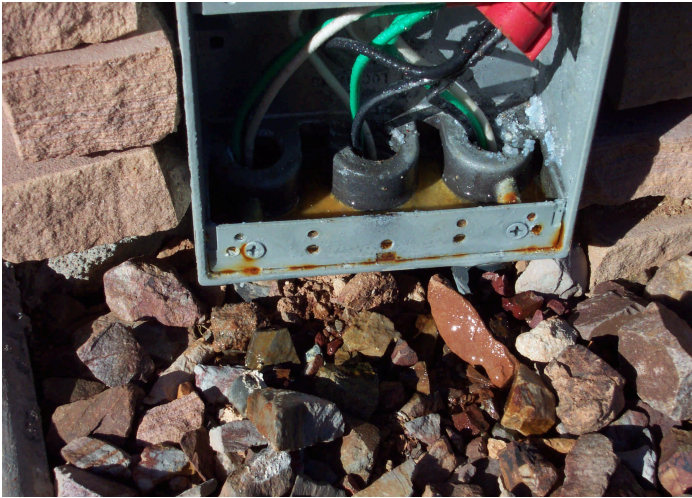
The Electrical Box at the front yard wall has moisture penetrating it. Moisture is likely entering from the light on the column. Recommend proper sealing of the light fixture to the post.

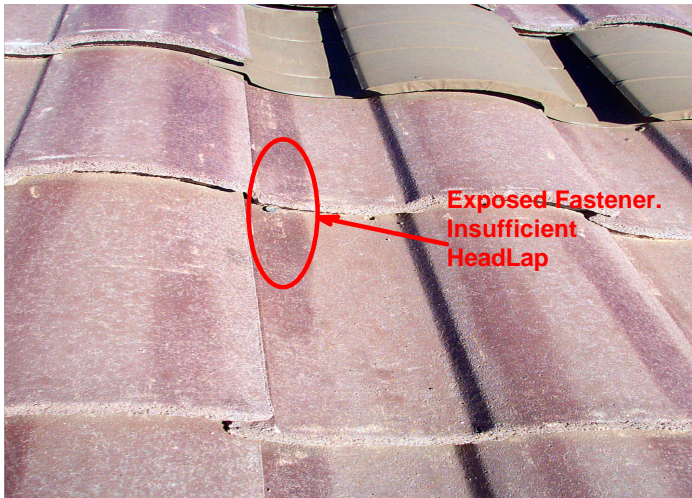
On the south side of the ridge near the vents 2/3 of the way towards the front of the house, there is insufficient head lap on the tile and the mechanical fastener is exposed.

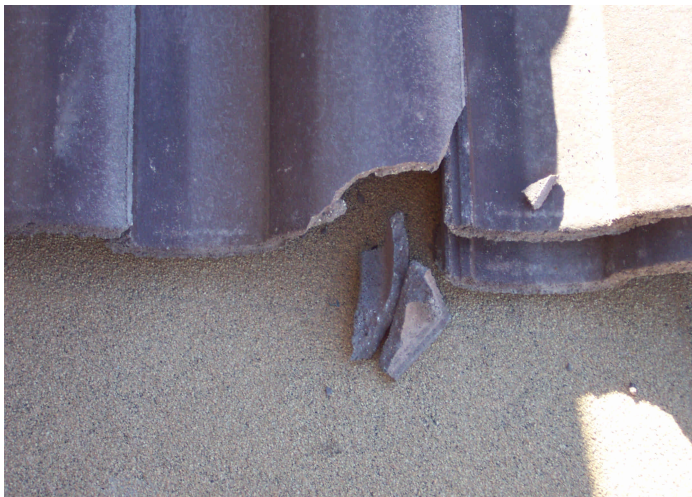
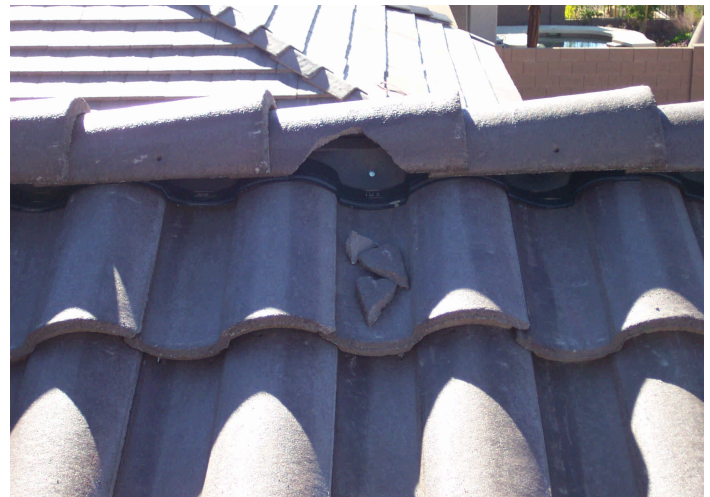
There are multiple broken tiles at the north face of the rear gable. Recommend repair of the broken tiles by licensed roofing contractor.

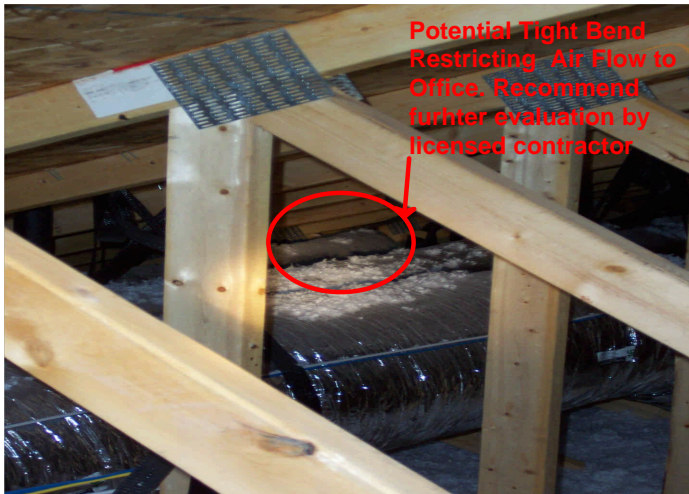
The airflow from the register in the office is less than the other areas. In the attic it appears that the duct may have a tight bend to it restricting airflow.
